MANAGING THE “RECEDING EDGE”

ABSTRACT

Cycle time, waste, defect, unfinished work, work structuring, standardization, cast-in-place concrete, takt time planning (TTP)

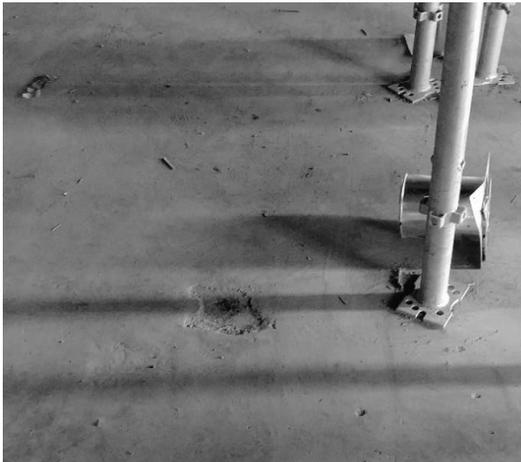
- 1. Floor Concrete Finishing:** Figure 1 depicts a floor where concrete work was “done,” but still required patching before a smooth surface could be handed off as “done-done” to the finishing subcontractor.
- 2. Ceiling and Wall Concrete Finishing:** Figure 2 depicts a wall/ceiling intersection with concrete leakage that occurs at the edge of the floor, causing excess concrete to dribble down and coagulate on the walls of the floor below. The resulting patches of excess concrete must be removed by a returning crew before the floor is cleared.
- 3. Left-over Materials and Debris Waste:** Figure 3 depicts a completed floor (“done”) where removal of debris and left-over materials is still required in order to handoff a clear space to the succeeding contractor.

Figure 1: Floor concrete holes requiring patching work

A 5 WHYs analysis on defects found on the concrete floors (Figure 1) identified as a root cause a lack of cleaning and lubricating standards for concrete formwork panels. A lack of standard process results in chunks of dried concrete remaining after a placement which, if not cleaned prior to the next placement, then cause the panels to stick to the new layer of concrete. This challenge stems in part from the fact that the contractor applies no

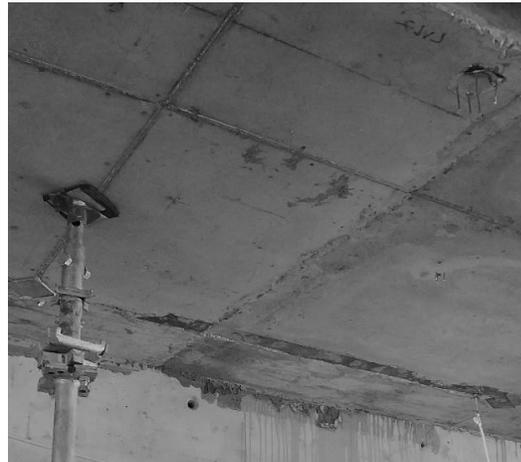
Figure 2: Ceiling and wall concrete finish requiring patching work

A 5 WHYs analysis on defects found on walls and ceilings (Figure 2) homed in on panel design and configuration constraints and identified two root cause of concrete leakage at edges. As panels are abutted to each other, there are gaps in-between them and some

leakage is expected. However, leakage can be excessive when these gaps get to be too large. One root cause is insufficient consideration given during panel placement in terms of skirting and grading. Another root cause is panels shifting and thereby leaving gaps between edges. We did not investigate approaches to address the first. Approaches to address the latter are (1) preventing the occurrence of concrete drippings and (2) providing a process for removing drippings after they occur.

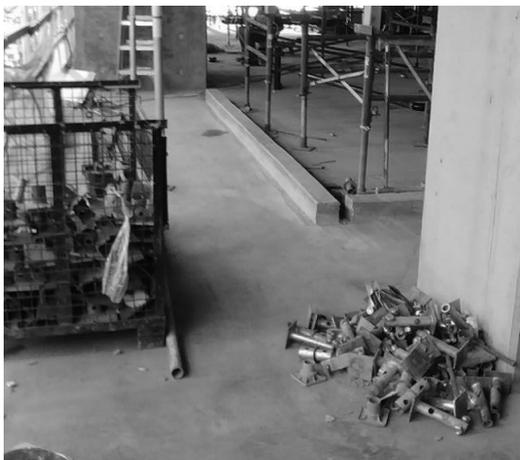
Figure 3: Waste belonging to Webcor Concrete that required removal

Waste comprised left-over materials and debris (Figure 3) that laborers must clear off the floor before being “done-done.” These materials were either in excess and needed to be removed, or were supposed to be reused but were left unsorted thereby making reuse

harder or misuse more likely. A 5 WHYs analysis on the presence of such waste identified as a root cause that no process was in place, or person held accountable, for cleaning up during work or after the completion of work. No standard was in place to define what is considered a clean workplace, and no process was implemented as work progressed to ensure that no waste would be left over.

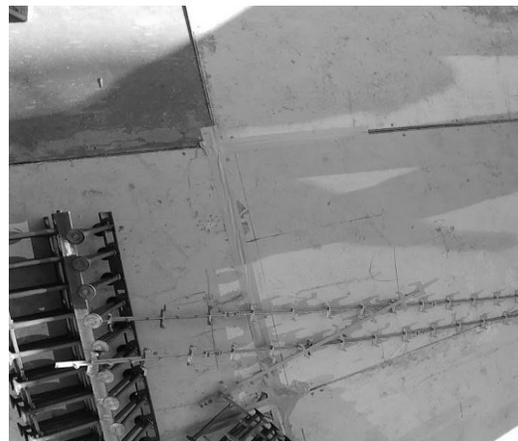
A preventive countermeasure is to close the gaps between the sides of panels. Figure 4 shows an example of the countermeasure observed on site, covering gaps with duct tape (or metal flashing) to ensure that concrete will not leak. These coverings had to be removed during stripping. Regrettably they also left spots to be patched by a returning crew.

Figure 4: On-site countermeasures taken when gaps between panels are too large

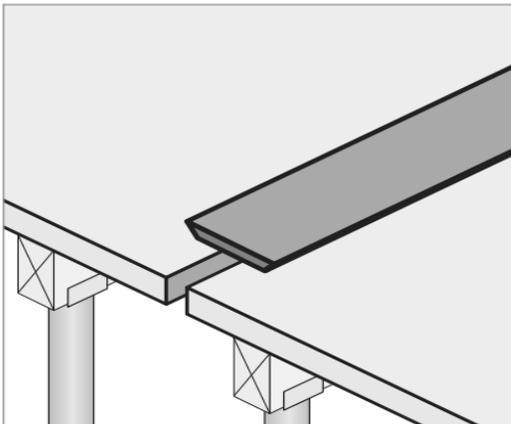
Many formwork accessories exist to prevent concrete leakage. Figure 5 illustrates joint panel strips used to fill gaps between panels or between panels and edges so as to minimize leakage and thereby make it unnecessary for the laborers to later grind concrete down.

Figure 5: Example of how joint panel strips work in model (Frank 2017)

The purchase and application of junction panel strips would come at a cost (though small, as the application is only on the edges) and require time to install before concrete placement. In return, elimination of the need to remove any duct tape or metal flashing used currently (Figure 5) to cover cracks, and reduction in leakage would later save time and labor. In tandem with this, a standard process similar to the process mentioned in the previous subsection should be developed within the formwork stripping procedure to ensure that any patchwork can be completed as soon as possible after a placement is complete as concrete hardens over time.

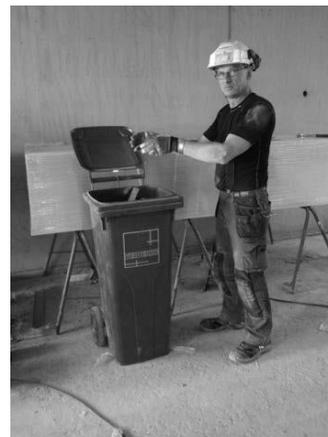
Suggested countermeasures are to facilitate cleaning work on a continuous basis, a part of a built-in-quality process. Every worker, when she or he has things no longer needed, should put them in a designated cart or personal trash container (e.g., Figure 6 illustrates a personal trash container used on a project in Norway). Carts and trash containers should be on wheels and be readily available to any worker. Carts must be labelled so that workers can sort reusable items immediately when they put them down. To promote sorting practices among workers, cleaning should be brought up in daily meetings by the foreman and practices must be systematized. For example, if at the end of one day, the foreman sees waste left on the floor, the next day they would mention it. New workers should be trained so that they know that “clean as you go” is, indeed, the rule and everyday practice. This built-in-quality process should in the long term sustain itself with self-inspections, but other inspections would probably be necessary at the beginning, while worker habits develop.

Figure 6: Use of personal trash container (Veidekke 2017)
