Challenges in Industrialized Renovation of Apartment Buildings

Ergo Pikas, Olli Seppänen, Lauri
Koskela, Antti Peltokorpi

Case Description

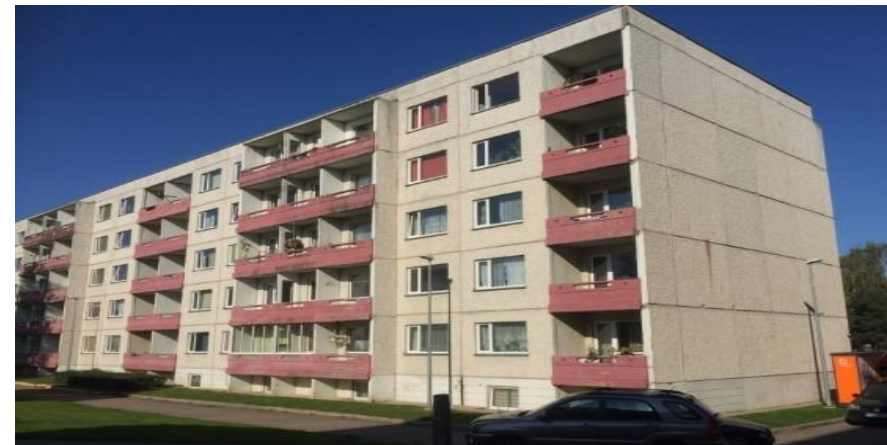
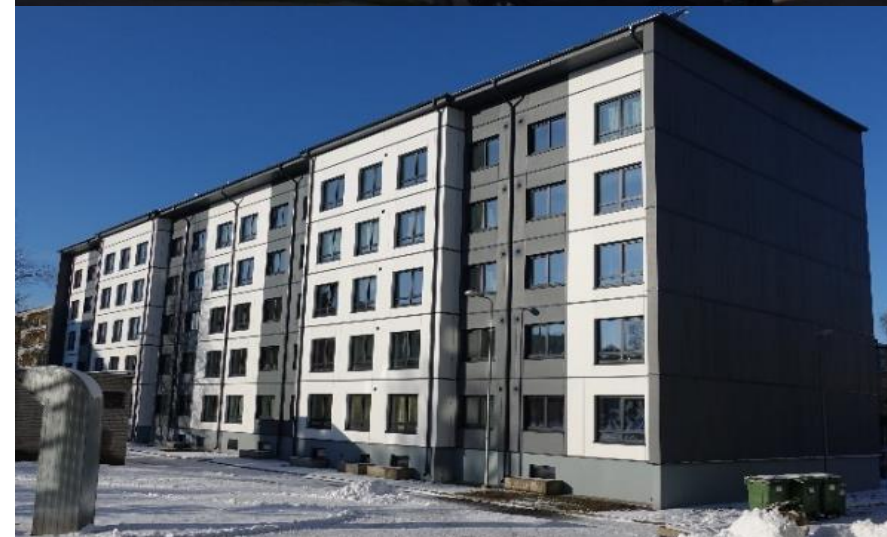
Objectives: A nearly zero energy building (105 kWh/(m² a) and research of industrialized renovation

Building: Five-story building (Soviet building type 121); 80 apartments; built in 1986

Conditions: External walls could not be removed as these formed an important part of the existing structural scheme

Energy Consumption: Measured primary energy use 300 kWh/(m² a)

Cost: Total 822 €/m² (121 €/m² general construction works, 251 €/m² finishing works, 334 €/m² on energy efficiency works and 116 €/m² on nearly zero energy building works)

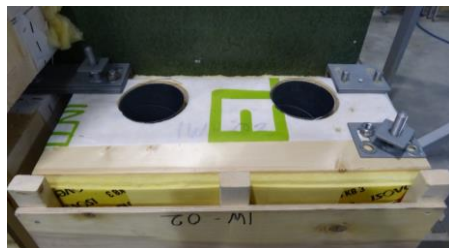
Windows and ducts in factory

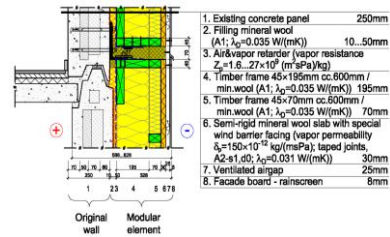
Design for MA

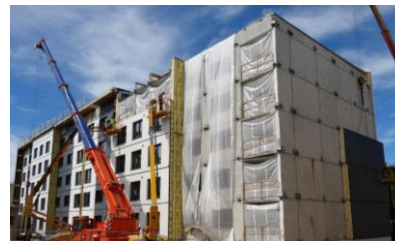
Installation on site
